Report: XXXXXXXXXXXXXXXXXXXX Factory Visit – 27/28 January 2015

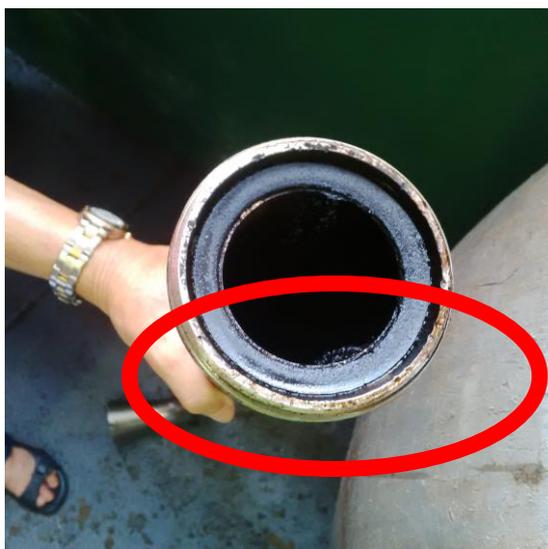
4. The pipes used to transfer the sauce from the cooking pots into drums for storage were found to have sauce in them from the last transfer process as well as a build up of black dirt (old product) inside them, showing that they are not being cleaned properly after use.

- b. A pipe cleaning and sanitising procedure needs to be developed and this should include the dismantling of the pipes during cleaning, **especially after transferring sauces that contain allergens.**
 - c. The pipes are currently stored lying across the tops of upturned drums after use. It is recommended that the pipes to be stored vertically after cleaning to allow for any residual water/liquid to drain from them.
 - For this purpose, it is recommended that clamps be made and mounted against the wall which can hold the pipes in vertical position when not in use;

- These clamps should be made from a material that does not scratch the pipes, as in deep microbiological analysis it will be found that unless thoroughly sanitised, bacterial counts from these scratches can be quite high;

- Covers for the tops of the pipes during storage to prevent insects and dust entering the pipes, should also be made.
6. Cleaning and sanitising procedures need to be written to address the cleaning of the utensils used for measuring and mixing the ingredients such as jugs, dishes, buckets and mixing paddles. Further, these all have to be cleaned with food grade chemicals – you need to have the MSDS of these food grade cleaning chemicals at hand - not with Sunlight liquid, which is a household chemical currently being used for this cleaning.

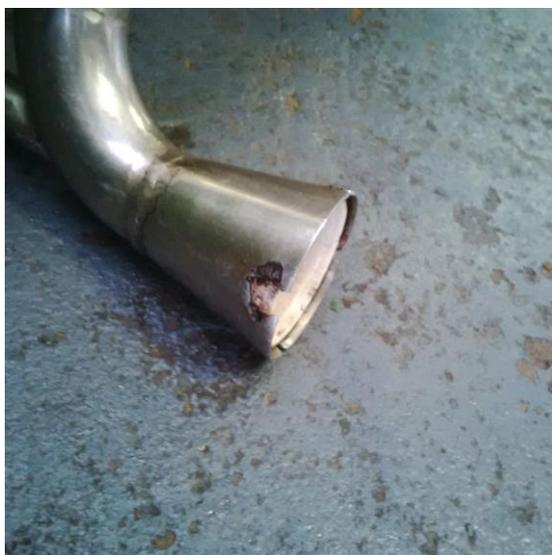
5. The following changes need to be implemented regarding the condition and storage of the pipes:
 - a. The broken metal funnel on the pipe has to be repaired or replaced as this is both a microbiological as well as a physical food safety hazard as dirt and bacteria will have accumulated here and is a potential source of contamination of the products.

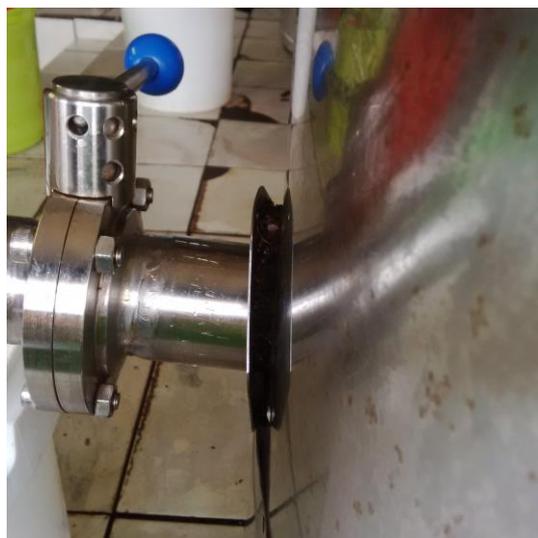
9. The broken tiles in the cooking area have to be replaced.
 10. The cooking pot on the right has a build up of dirt behind the plate at outlet pipe. This dirt to be removed and the plate has to be pop riveted back into position to prevent this build up from occurring again. The other cooking pots have to be checked for missing pop rivets as well to prevent this dirt accumulation.

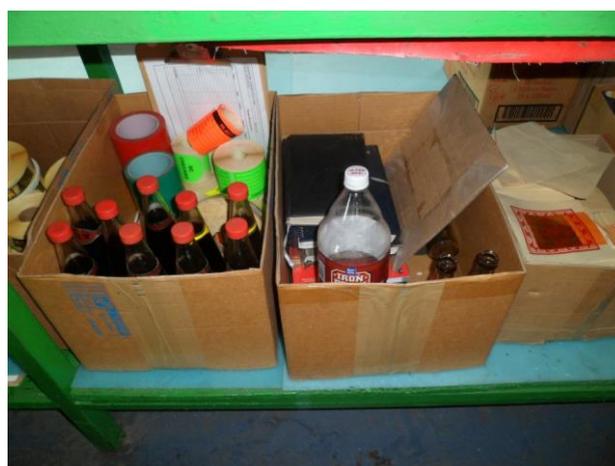
17. Personal effects such as handbags, cooldrink and peanut butter bottles ***should not*** be stored in amongst the labels below the work tables in the labelling area.

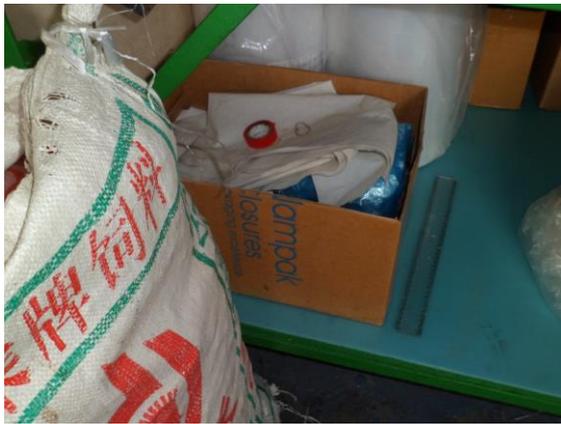
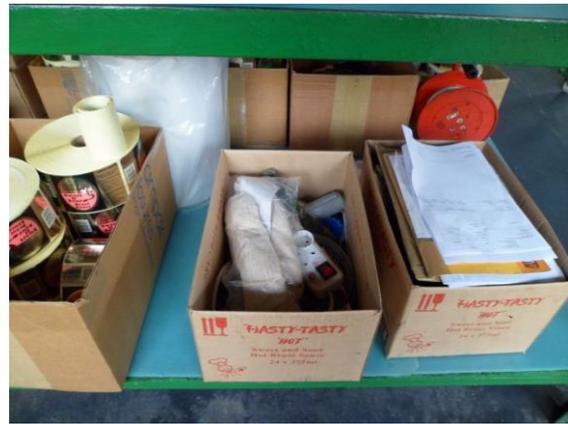
18. Cupboards are needed to store the labels and mechanical consumables such as insulation tape, lubricant, rubber currently stored in the area below the work tables as well.

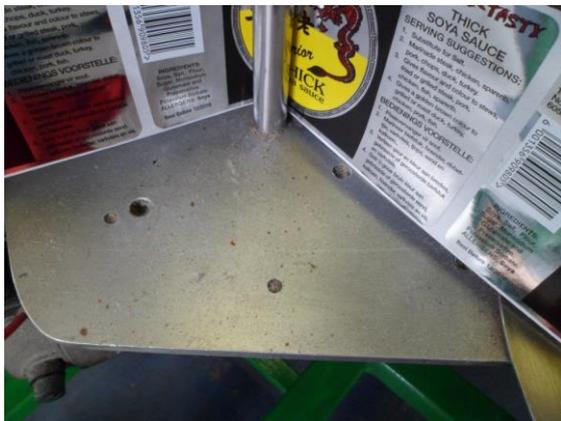
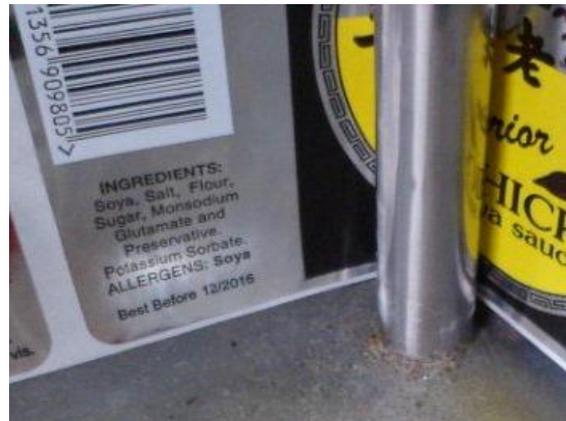
19. The chemical cupboard needs to be labelled.
20. All broken storage drum lids have to be replaced.
21. All visitors to the premises have to complete the Visitors Health Form and be given coats and hair nets to wear when entering the factory premises.
22. Production documentation is to be stored on a table separate from the labelling table.
23. We have noticed a spelling error on one of your labels – the **XXXXXXXX XXXX XXXXXX XXXXX**. Please look very closely at the photo and the enlarged section below...

Monosodium Glutemate is spelled Monsodium – the second “o” is missing.
